Aaron D. Spooner  
Louisiana State University

University of Florida International REU for Gravitational-Wave Physics

Understanding the properties of fused silica fibers for Virgo's current Gravitational Wave  
interferometer mirror suspensions

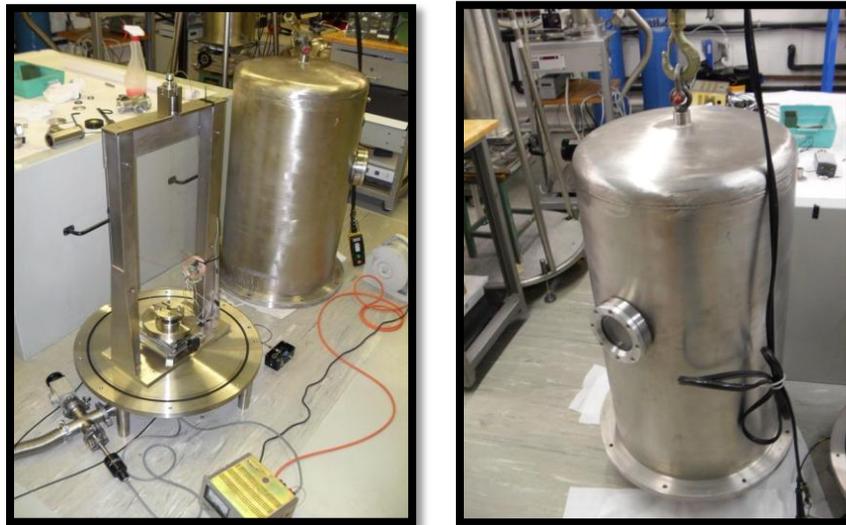
*Figure 1: mounting mechanism designed to support fiber (left) and the chamber (right) used to create a suitable vacuum to simulate Virgo conditions*

design. The chamber design or "hat" has incorporated a metal with properties that appear to be closely related to most aluminum alloys as it is not magnetic. The mechanism stands at 1.1 m and has a base with a diameter of .60 m which supports the framework of the mechanism's mounting bracket. The circular base has inscribed within its surface a secondary ring that is required for O-ring insertion. This secondary ring is required for establishing a vacuum once the O-ring has been inserted. If the O-ring is not properly aligned with this inscribed ring then a proper vacuum cannot be achieved. After lowering the chamber, the apparatus is contained and the inside is only visible through a single viewing port .68 m above the ground. Fortunately, it is possible to see everything within the chamber. Unfortunately, a light source is required for better illumination and construction of this lighting system will be discussed at a later point in this report.

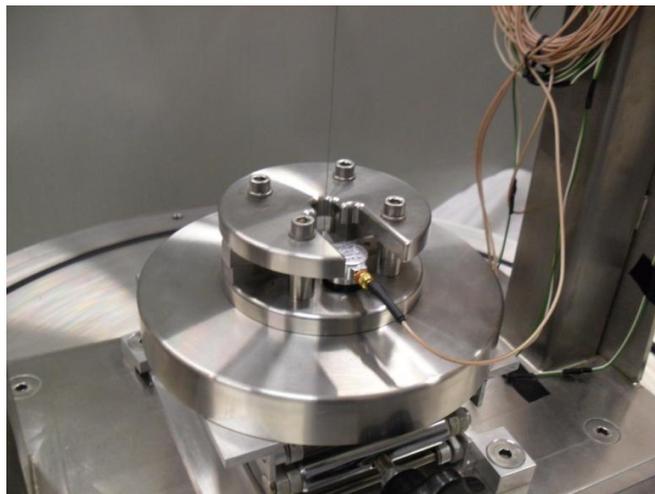
*Figure 2. Image of 5.6 kg test load with channel piezoelectric accelerometer attached and designated as channel 1 or "green" sensor*

After understanding the vallen acquisition system, the next step involved establishing a suitable contact without the use of metallic clamps. As the provided magnetic clamping mechanism did not provide for a balanced system nor a suitable contact as a result of the material's weak magnetic attraction, wax was the appropriate and non invasive option. The applied wax must be uniformly distributed between the accelerometer and the surface on which it is being applied. Failure to establish a smooth, even contact results in extra noise in the Vallen Visual Acoustic Emission diagrams. Even though in most cases this noise was confined to a certain amplitude range, the interference inhibited proper analysis. In order to detect isolated incidences within and around the fiber, the system must maintain silence at all times. In reference to figure 2, the noise was confined to amplitudes ranging from 40 to 43.5 dB. This confinement allowed for proper background noise extraction. Knowing the set range of interference, it was possible to properly adjust the accelerometer. Eventually, with practice and small, evenly spaced coatings of wax, the system achieved an adequate silence level. As it was extremely difficult to eliminate all forms of background noise at this stage in testing, the elimination of interference induced by an uneven contact was a considerable achievement.

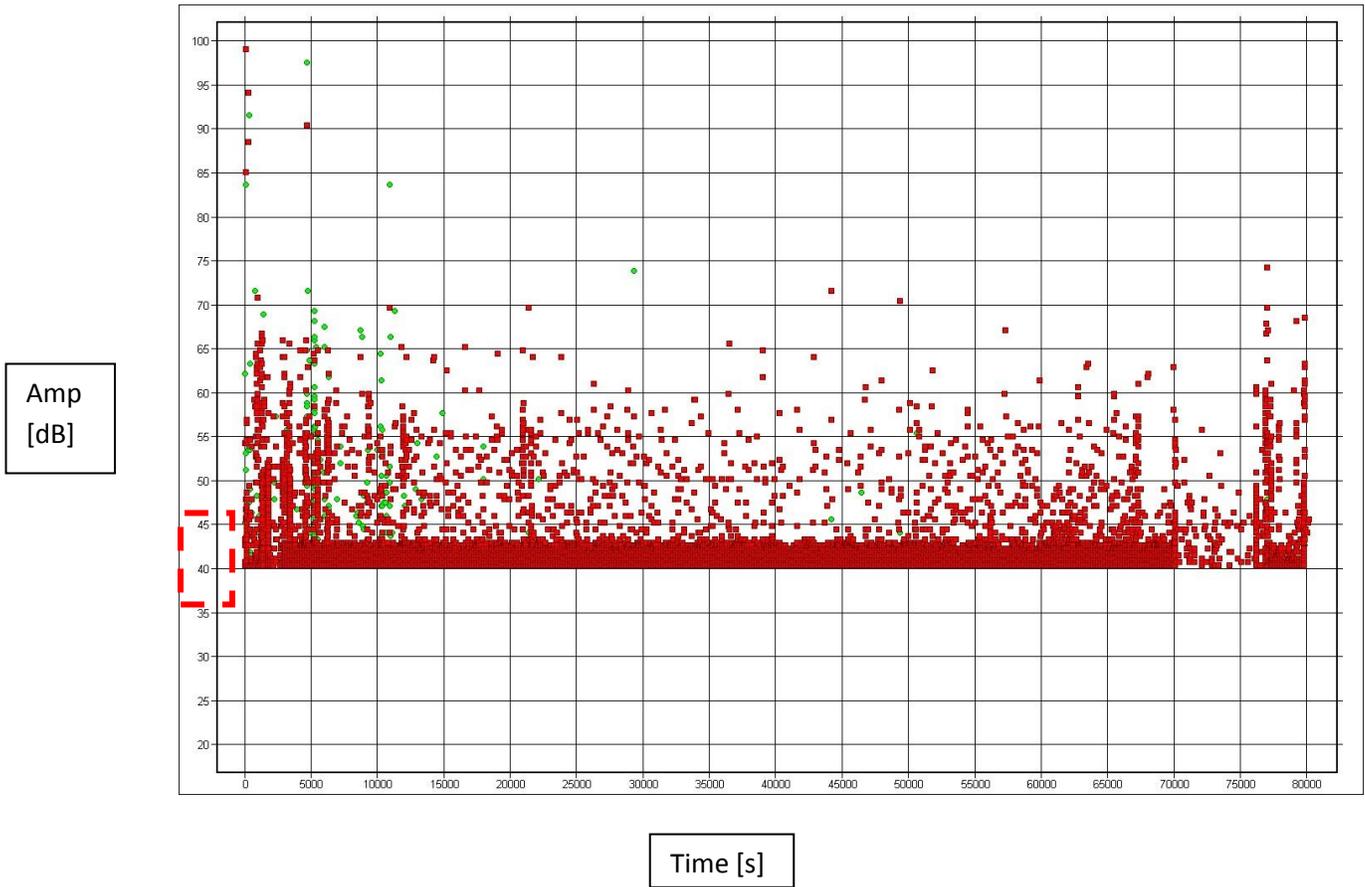
**Figure 3: Diagram illustrating improper wax distribution as indicated by an uneven surface or unbalanced accelerometer.**

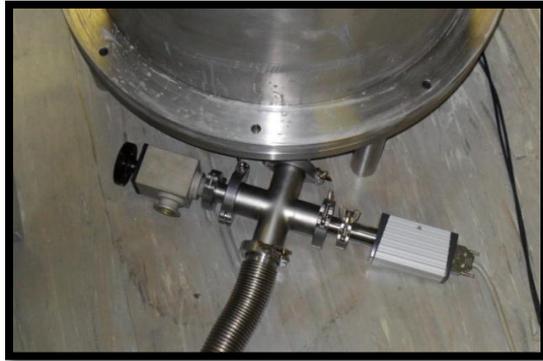
**Figure 4:** Picture of pipe set up with air inlet (left) and Vacuum gauge sensor (right) attached.

Preliminary tests were run on the Aluminum fiber with the Vallen Acoustic Emission system, assembly of the vacuum chamber began with locating and allocating special pipes. Next, while wearing latex gloves pipes must be thoroughly cleaned with alcohol before any connections are made. When every component has been properly cleaned, pipes are adjoined with O rings. After inserting these O rings into the rim of the pipe, clamps known as "ties" were attached around the adjoined pipes in order to establish an air tight system. Following pipe assembly, certain monitoring instruments were attached to open ended portions of the pipe. Specifically, the left port was designated as the air inlet and the right port functioned as a conduit to the Vacuum Gauge controller. The Vacuum Gauge provided digital readings of the pressure within the chamber. This device allowed one to determine whether or not the vacuum was sufficient for the purposes of the experiment.

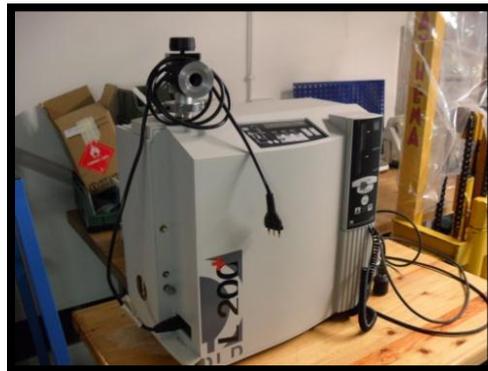
**Figure 5:** Image of leak detector.

Prior to configuration as an effort to optimize the vacuum and eliminate all leaks, the Leak Detector was implemented. This process incorporates  $^4\text{He}$  as a method of determining if there are any porous areas that could serve as potential air inlets. As a result of Helium's low mass and low percentage in atmosphere, this element is used in order to bombard a given area as a means of detecting a leak. Referred to as the "outside-inside" helium leak testing technique, the component being tested is connected to the detector and vacuum sealed. After establishing a vacuum within the attached component, Helium is sprayed over the entire surface. Within the detector, there lies a mass spectrometer.

If the Helium penetrates any portion of the component being tested then the mass spectrometer will detect the leaked Helium. As this system can detect leak rates up to  $1.8 \times 10^{-5}$  mbar, the detector was most favorable for the desired  $1 \times 10^{-4}$  vacuum.

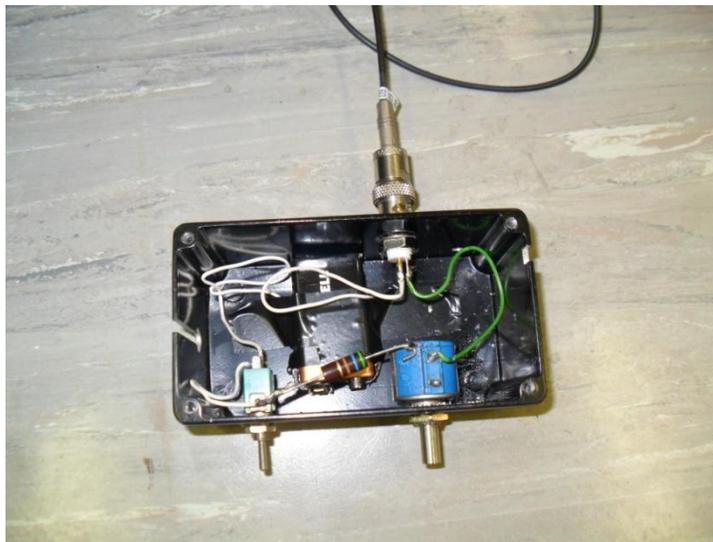
*Figure 6. LED lighting system control box*

After assembling the vacuum chamber, it soon became apparent that the inside of the chamber was extremely dark. In response to this lack of visibility, a LED lighting system was designed in order to monitor the preliminary Aluminum fiber. The components of this system were quite simple. Using only a basic resistor, switch, 9 volt battery and LED; a light source was established and attached underneath the top mounting bracket.

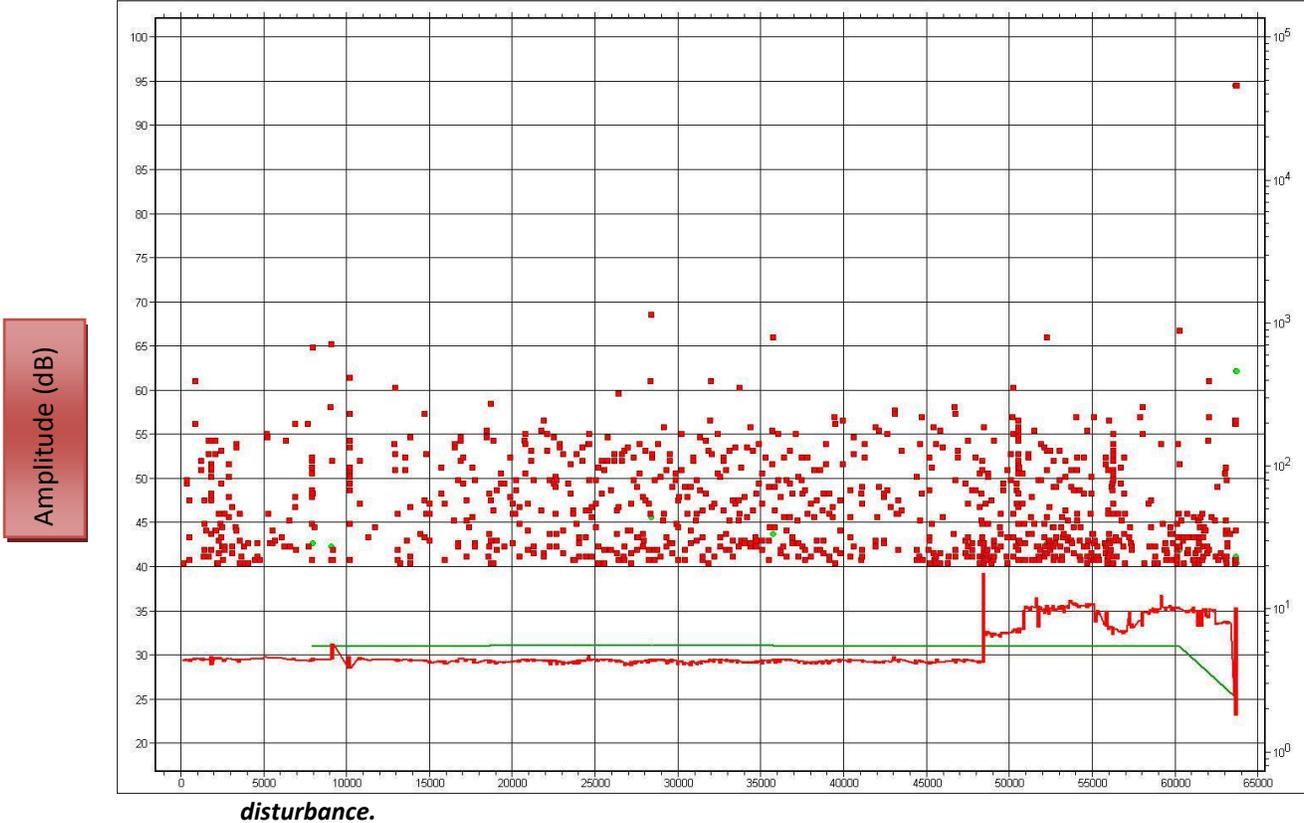
**Figure 7: Vallen Visual Acoustic Emission diagram showing six incidences of possible internal**

microscopic crack or fracture within the given material. Deformations could appear as slits or a rip with a wide assortment of geometries. Despite the impeccability of the material, these deformations could readily appear at any given moment in time as a result of a diminishing bonding strength in the material. Supporting the existence of micro cracks, Vallen Acoustic Emission data file... shows six isolated disturbances within the fiber during an overnight test run.

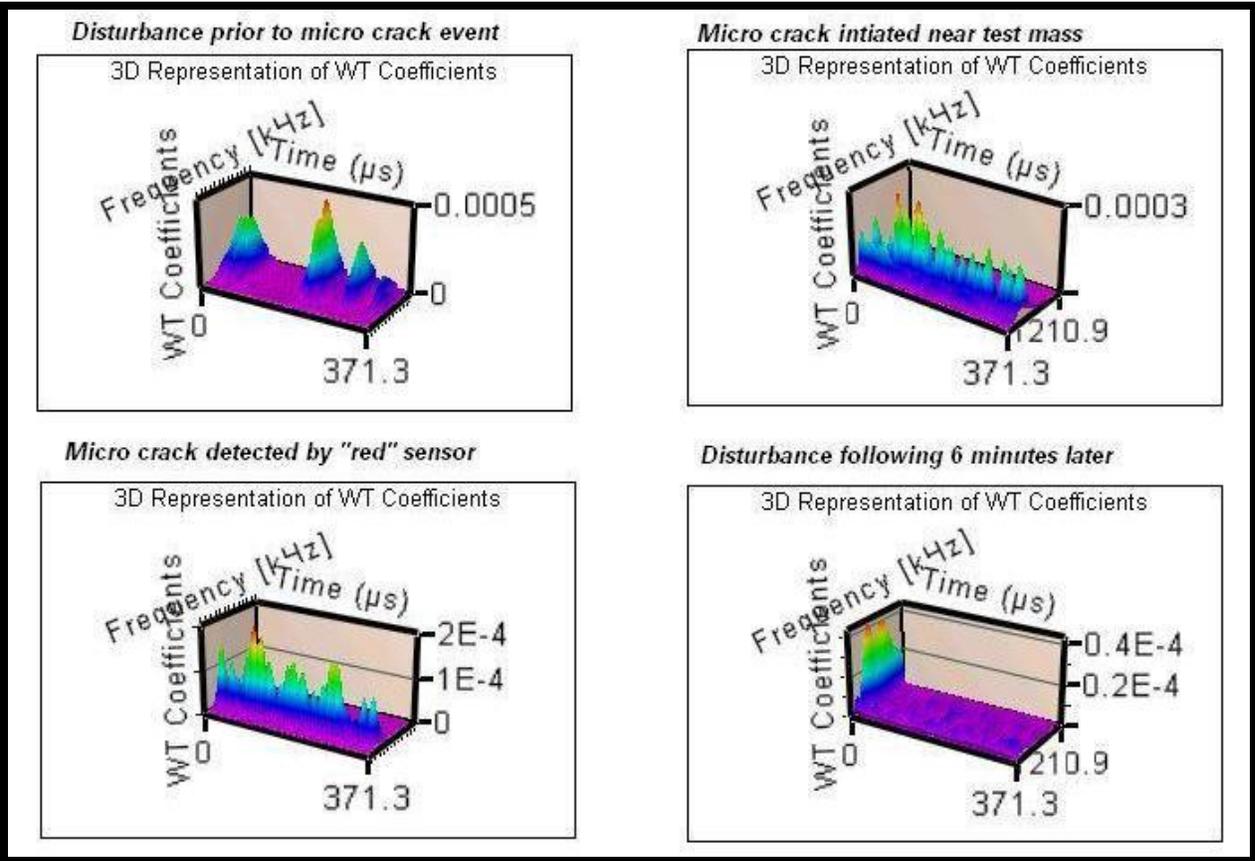
Figure 8: Possible micro crack detection as depicted by this 3 dimensional progression.

Using the wave applet feature of the Vallen Acoustic Emission system, a particular Vallen Visual AE diagram was analyzed and converted into a 3 dimensional image of the respective hit's frequency. These images consisting of 4 peculiar hits illustrates a possible micro crack detection. Upon reviewing these graphs, there exists a slight difference in the wavelet coefficient and the intensity of the 3D graphs in direct correlation to their respective energies. This correlation, in future tests, may establish a way for determining deformations

within the fused silica fiber. In addition to verifying these deformations, it may be possible to determine the crack width, geometry, and location. Although crack length and geometry may prove to be most challenging within the allotted programs, finding the source of propagation can be achieved by analyzing the recorded hit energy. If the energy appears to be greater near a particular accelerometer then the disturbance originated close to that particular piezoelectric. In this case, the energy appeared higher near the test mass. In similar response, the energy appeared diminished near the mounting bracket or "red" sensor.

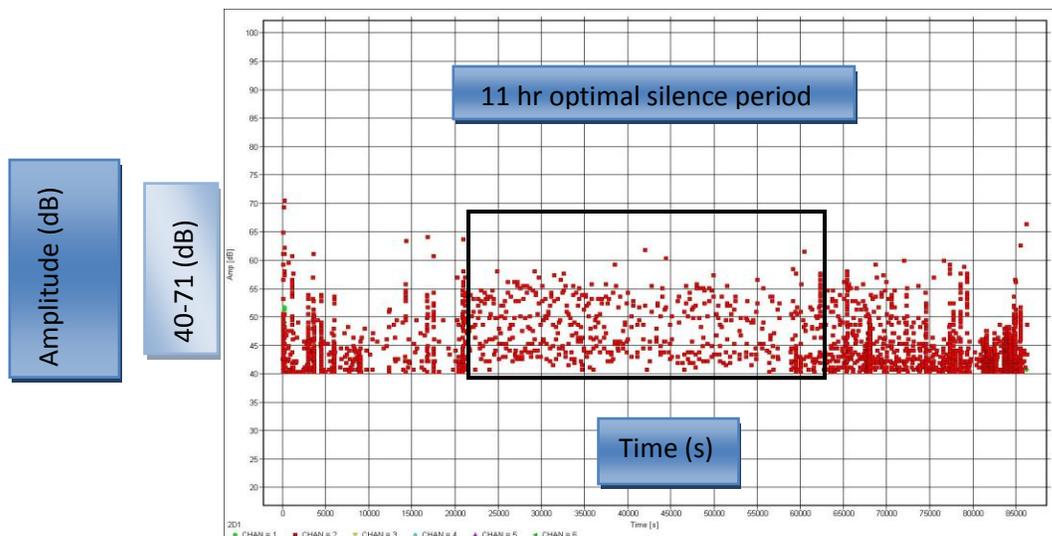
**Figure 9. A Vallen Visual AE diagram depicting a 20 hour acquisition run with an 11 hour optimal silence period as a result of an absence in light and human activity.**

high and low temperatures, x-rays, gamma rays, and electromagnetic fields all contribute to false vibration measurements. Eliminating several known erroneous inputs, the remaining false input that shall be discussed, as it is one of few verified false signatures, pertains to electromagnetic fields. This electromagnetic interference or "EMI" emanates from laboratory lighting as denoted by several Vallen Visual AE diagrams. Reviewing the data and comparing the densities of hit points, the amount of vibrations recorded within the system appear to be greater during the day. Shedding even more light on the situation, alternating the current by switching the above laboratory lights on and off produced sudden spikes in the Vallen Visual AE diagrams. If this alternation endured for a significant amount of time then consistent streams of background noise emerged. This inductive coupling originated from the proximity of cables carrying high AC currents. "Current spikes" coming from quickly switched circuits and other high frequency currents may also produce this source of electromagnetic interference. Fortunately, this emergence dissipates over a given period of time. However, this dissipation period constricted accurate data analysis to a minimal acquisition period. As a cleaning tool, the pulsing capability of this particular piezoelectric accelerometer enables one to actively reduce these false signatures. After proactively inducing an electromagnetic interference, initiating pulses from either channel will automatically counter this EMI. For future tests, magnetic shielding should be taken into consideration.

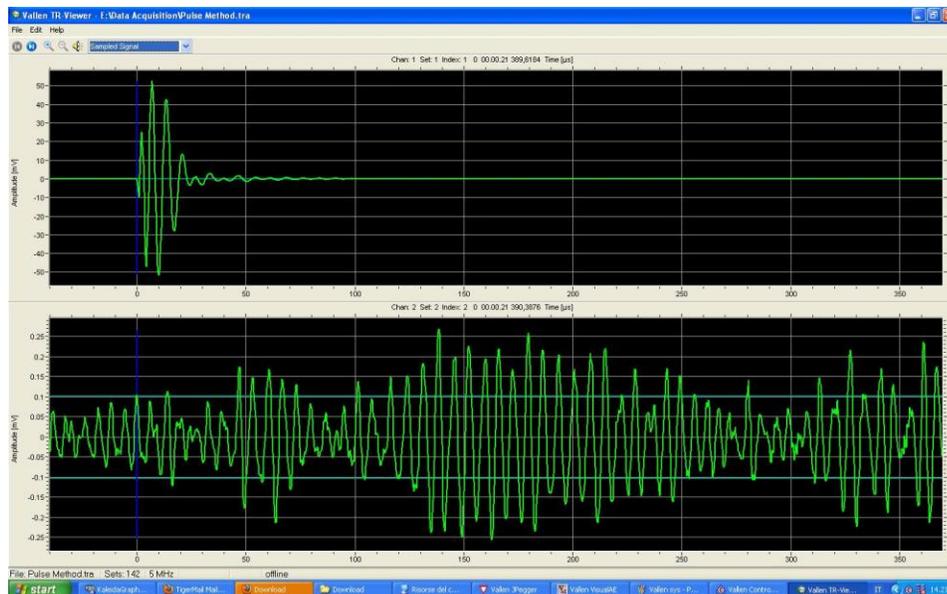
**Figure 10. Image of a Vallen Visual TR Viewer graph of a pulse sent through channel 2 (top) and recieved by channel 1 (bottom)**

Vallen Visual AE data showed echoes in most diagrams while pulses were emitted from channel 1 and channel 2. If the acquisition recorded pulses for an extended period of time then several echoes emerged. These echoes or receiver counterparts proved to be quite useful for analyzing particular aspects of how the pulse effected the fiber. In reference to the existence of cracks in the material, these pulses led to further deformation investigations. Using these pulses established a method that could be controlled and monitored. With this Pulse Method, in order to identify external disturbances pulses were sent through both channels and studied. The echoes hit energy, time delay, and amplitudes were recorded. Pulsing also illustrates the direction of the wave propagation. In reference to the figure(indicate) below, if pulses are input from the test load then the difference in amplitude between the two sensors appears greater than pulses emitted from the sensor attached to the mounting bracket. (Record amplitude diff) Also, during this particular run (refer to graph) the reception of pulses at the top showed displayed hits of slightly different amplitudes and energies. The pulses received at the base followed a more linearly consistent pattern. (record amp and at what time duration)

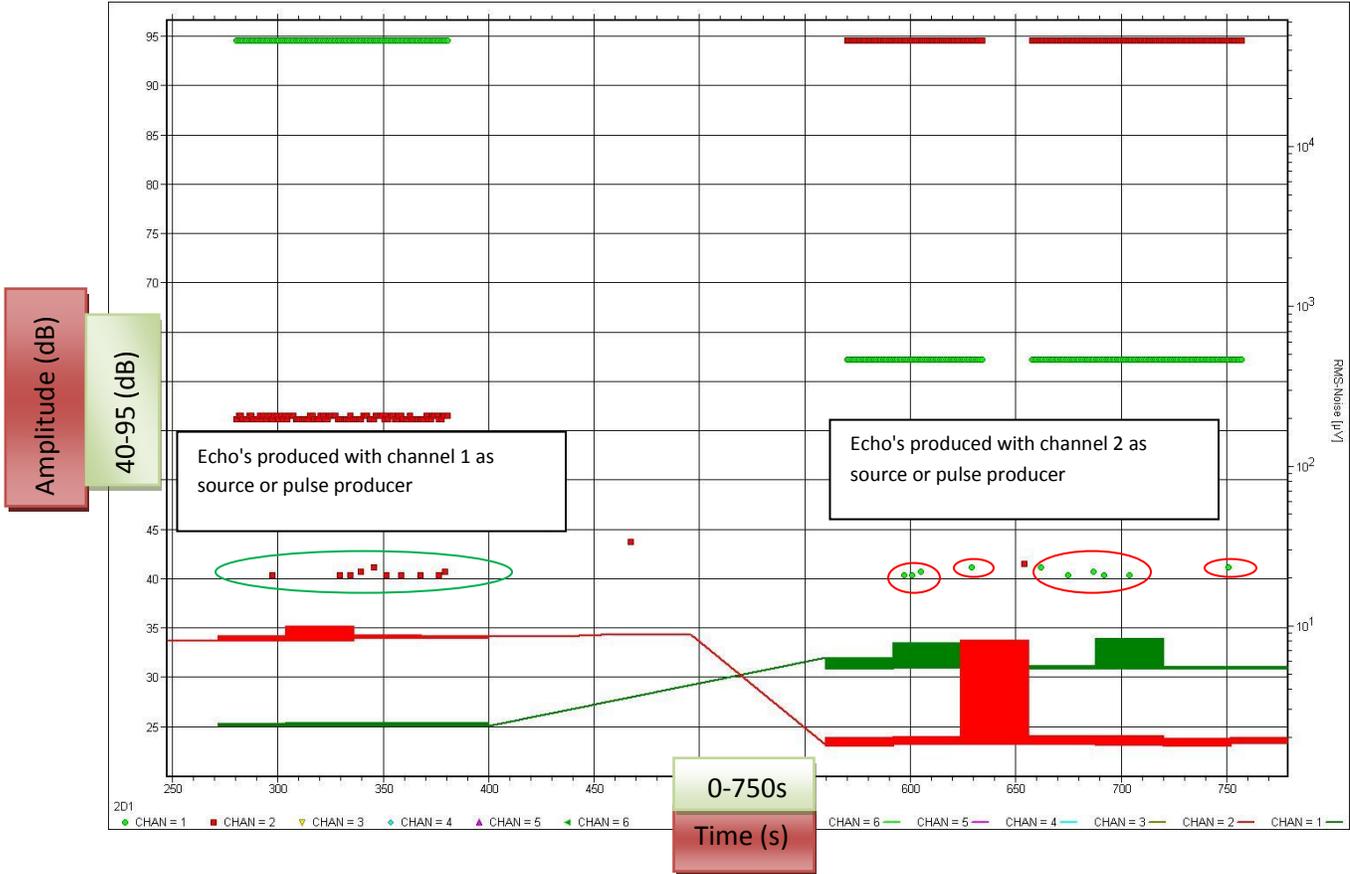
Figure 11. Vallen Visual AE diagram showing "hit" depicting echoes from both channel 2 and channel 1 counterparts respectively

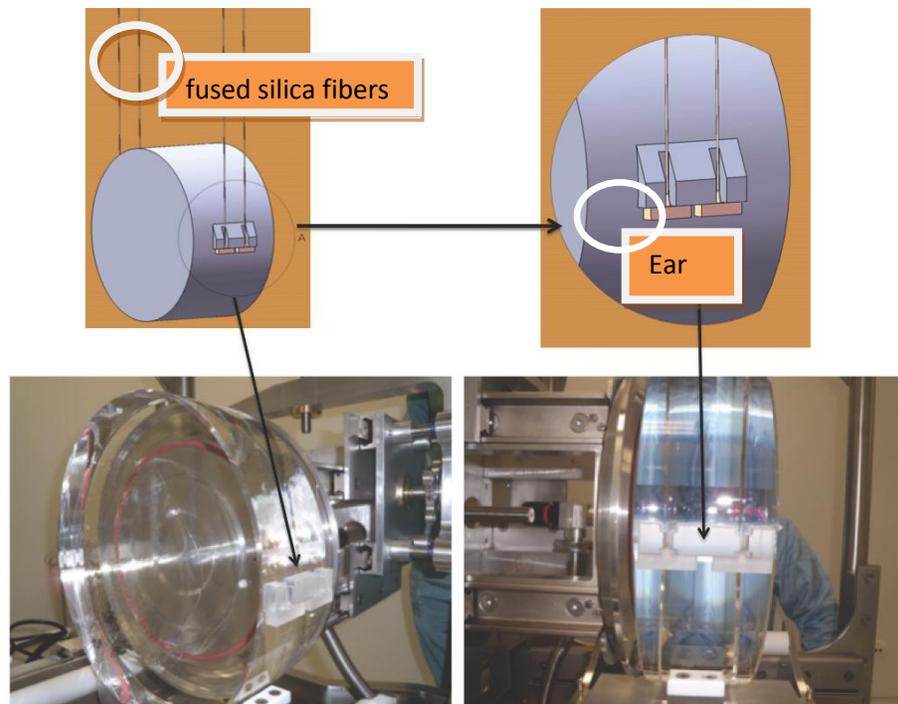
Figure 13. Images of interferometer mirror with fused silica fibers attached.

As a component of understanding the fiber's behavior, exploring the bonding capabilities is required as the fiber is too fragile for any type of welding. Gluing the fibers as a means of attaching the fiber to the interferometer mirror is the better option. Similar to the fused silica fiber, the bonding agent must be a clean solution, possess ultra high vacuum compatibility, and be non-dissipative. Adjoining the fiber and the mirror, an intercessor is used. This intermediary is more commonly known as the "ear" of the construct. As seen below in figure 11, the ear serves as a supporting block. Reconfiguring the Si-O bonds in  $\text{SiO}_2$  chains, the silicate bonding procedure is the alternate method for attaching or "gluing" silica fibers. This bonding procedure uses extremely pure components such as flat surfaces, ultra-pure water, and the catalyst potassium hydroxide (KOH). The procedure begins with hydration where a drop of a pure dilute KOH solution is used to wet the surface being glued. Next, etching occurs from the KOH solution because of the presence of the  $\text{OH}^-$  groups. As a result of this presence, Si-O bonds are broken and  $\text{SiO}_3^{2-}$  are produced in the solution. The last step involves dehydration.  $\text{OH}^-$  strips the  $\text{H}^+$  from the silanol group on the surface forming water. Si-OH groups dehydration produces Si-O-Si bridges. Ultimately, the  $\text{SiO}_3^{2-}$  chains connect the two surfaces completing the gluing procedure.

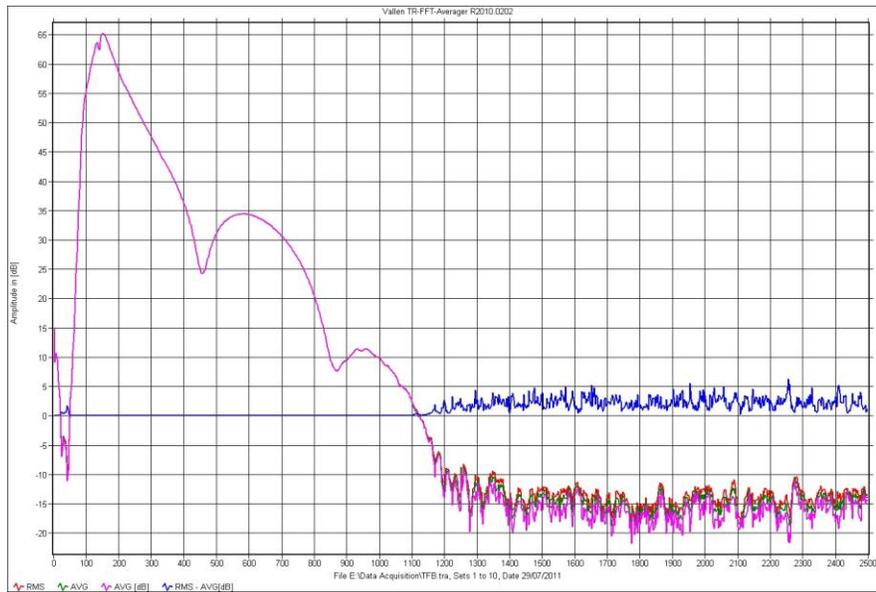
**Figure 15. Image of FFT depicting waveform produced by pulses sent through channel 2**

Two fast Fourier transform (FFT) plots were produced using the Vallen acoustic emissions program FFT avg applet. The first plot (figure 13) represents pulses emitted from channel 2 and the output as denoted by channel 1 is seen through the second plot (figure 13). Another set of plots were taken in the same fashion, however; the pulses were sent through channel 1 and received by channel 2. A ratio of these two scenarios were taken and are being analyzed by researchers at the University of Rome.

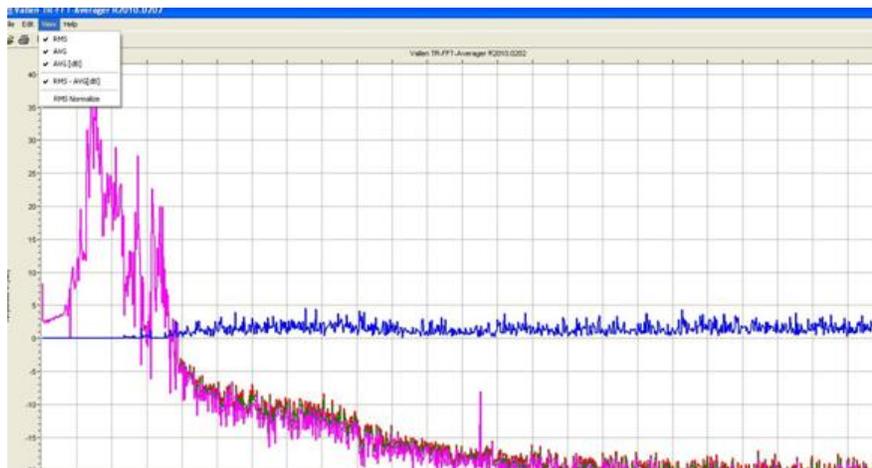
**Figure 16. Image of FFT depicting waveform produced by pulses received through channel 1**
